When the Fire's Out, the Job's not Done BAER Teams Protect Lives and Property

By Pete Cafferata, Forest Hydrologist & John Munn, Soil Erosion Studies Project Leader, Sacramento Headquarters

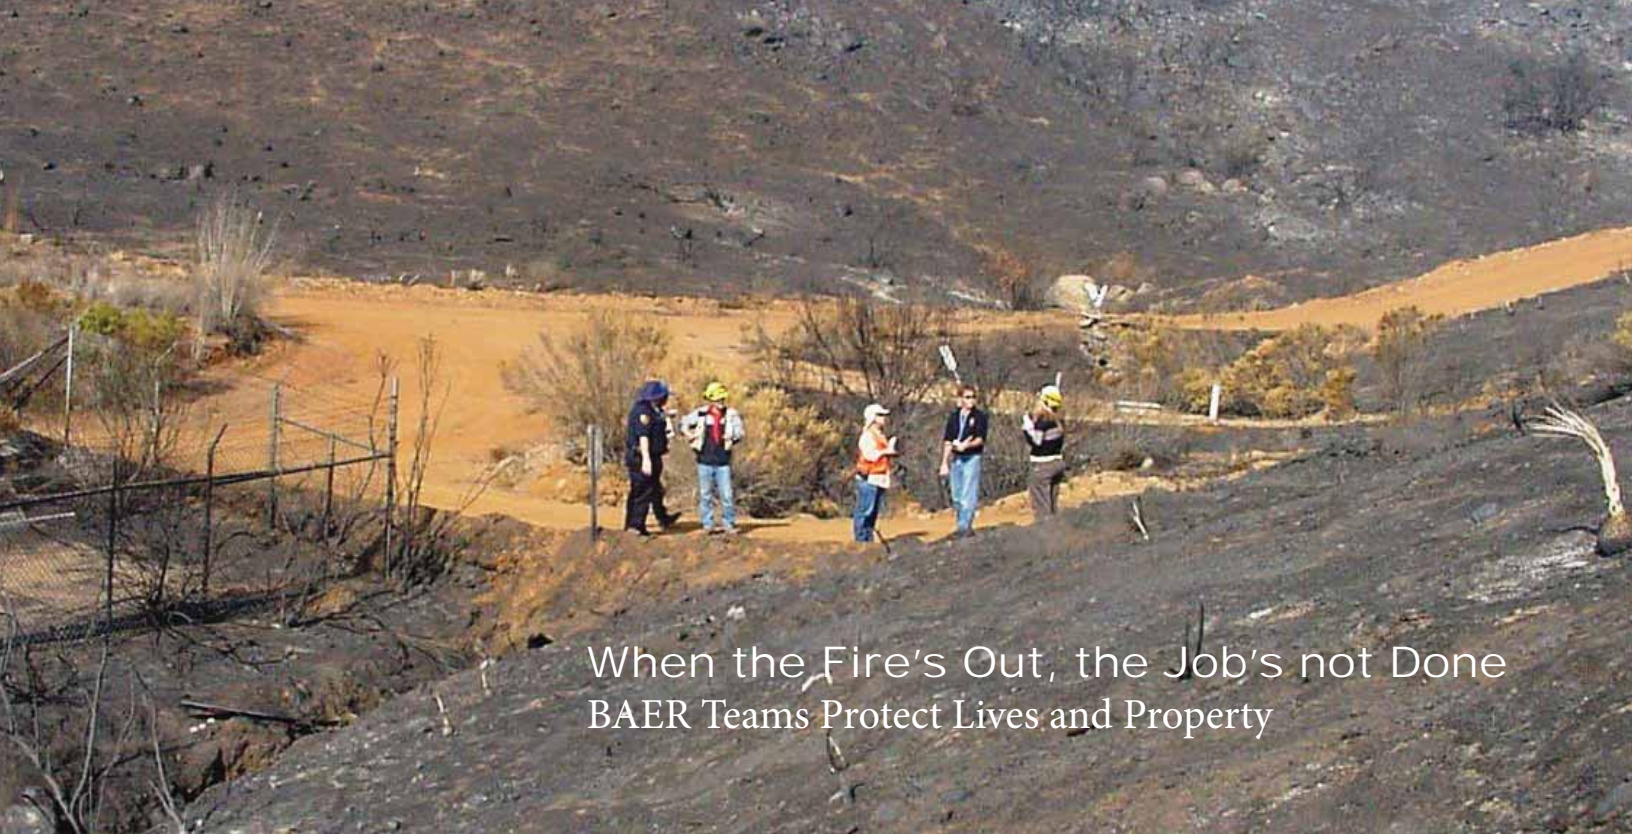
above: Rice Fire state BAER team examines burned watershed above Red Mountain Reservoir in San Diego County. Photo by Pete Cafferata.

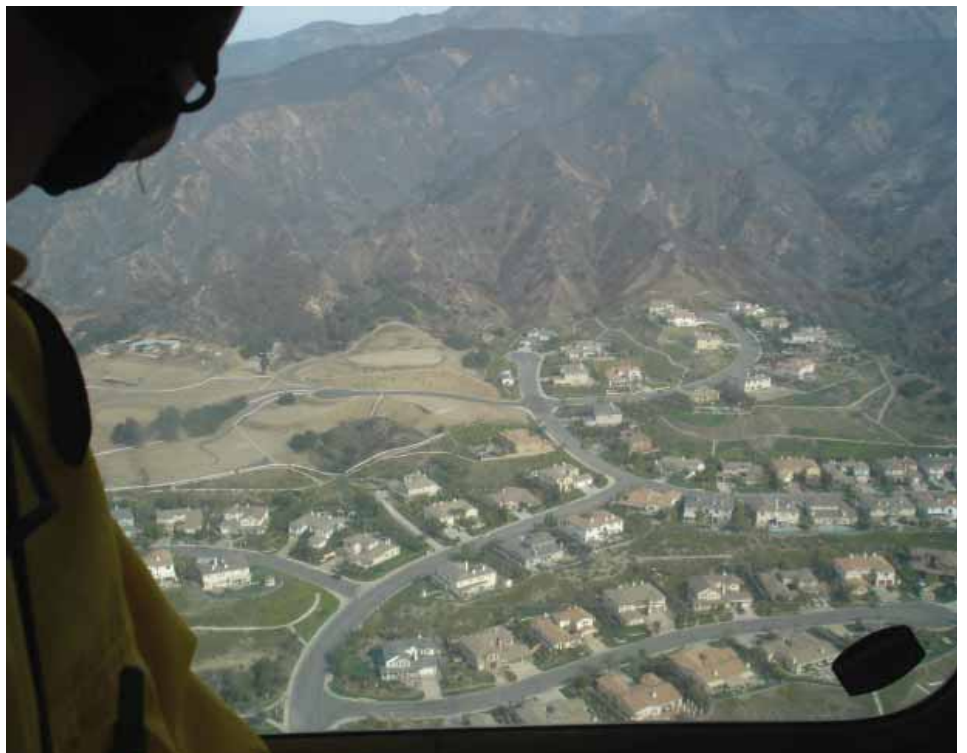
right: Dave Longstreth, California Geological Survey, views homes at risk in the Santiago Fire during a helicopter reconnaissance flight. Photo by Clay Bradow.

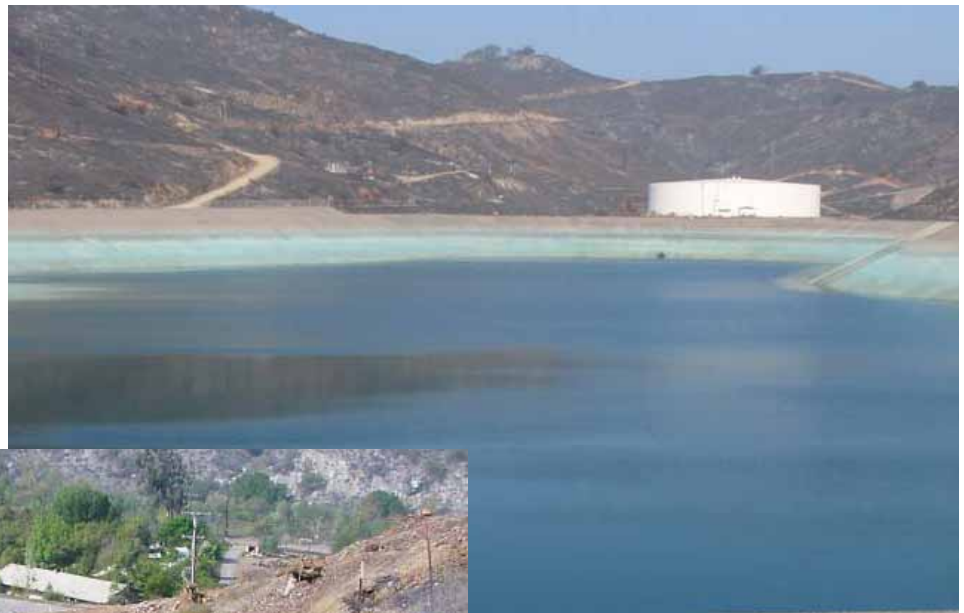
left: Houses evaluated for risk of mud slides below a burned steep drainage from the Rice Fire in San Diego County. Photo by Pete Cafferata.

Typical team recommendations included the need for detailed follow-up inspections at sites with a high risk to human life from landslides and mud flows and the use of rain gauge systems with telemetry to provide "early warning" for homeowner evacuations. Measures for protecting threatened or endangered (T/E) species and archeological sites were also recommended.
